## Colorado Haiti Project: Saint-Paul School Structural Improvement Report

## Introduction:

### **Report Objective:**

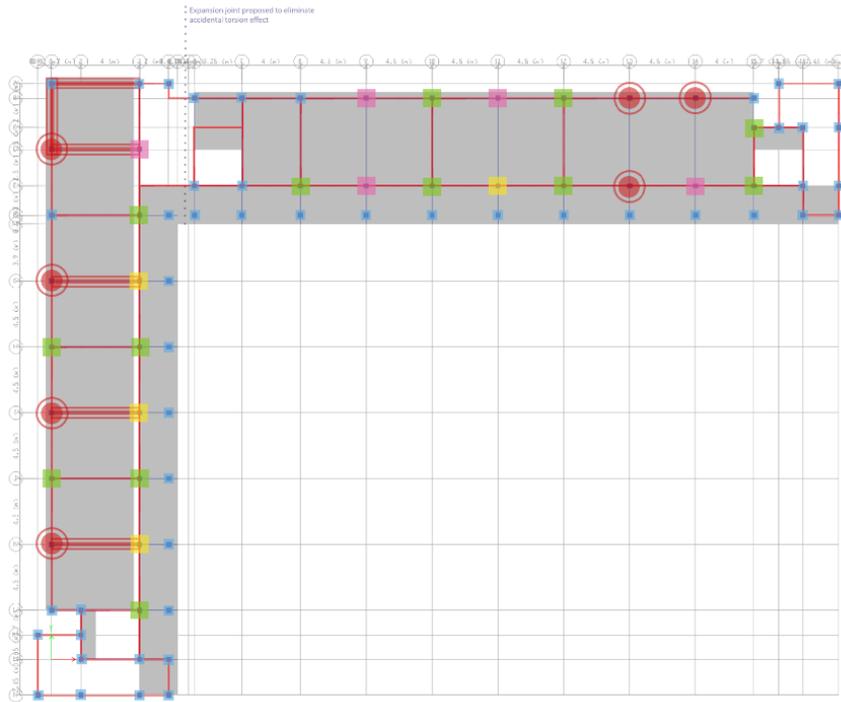
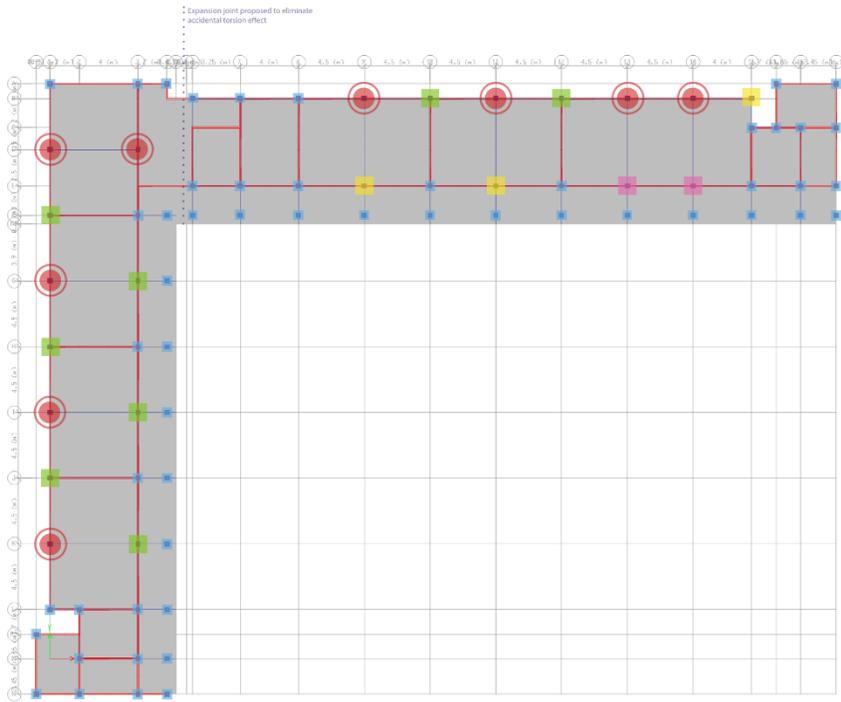
Diagram 1

Poor construction has led to failures in the structural frame of the building. Failure does not mean that the building will collapse but it does mean that the weight and pressure of the building itself is over the capacity of the structural component given the inadequate strength of the concrete and the undersized rebar. The failure of these components is amplified by the saturated soil and the lack of expansion joints, which has resulted in cracking of the walls and roof throughout the structure. The following structural components have failed or are at the limit of capacity and are located in diagram 1.

- 16 columns (7 first floor and 9 second floor) are over capacity and are in a state of failure
- 7 columns (5 first floor and 2 second floor) are in high demand and at the limit of capacity
- 6 beams on the first floor are over capacity and are in a state of failure

The buildings structural frame has failed and issues will continue to degrade if the components are not reinforced. Further failure caused by seismic activity could cause catastrophic failure and BHI recommends immediate repairs. Despite the structural failures, the building can be salvaged by making the following improvements:

- 2. Reinforce Structural Frame** - The columns and beams that have failed will need to be reinforced by excavating and pouring new column footings and installing steel columns and beams to reinforce the existing structure. The columns will be located inside the existing columns (A typical detail for this type of reinforcement can be seen in image 1). The steel will be connected to the existing concrete columns with threaded rod, which will be epoxied into columns on either side of effected rooms. A new steel beam will be connected across these columns and carry the additional demand across the failed beams. The columns on the second floor will also need similar reinforcement but further review will be necessary to determine a final design for reinforcement. The steel structure will reinforce the failing concrete columns and beams and improved footings and drainage will eliminate settlement issues. Diagram 2 shows the locations of the proposed steel reinforcement.

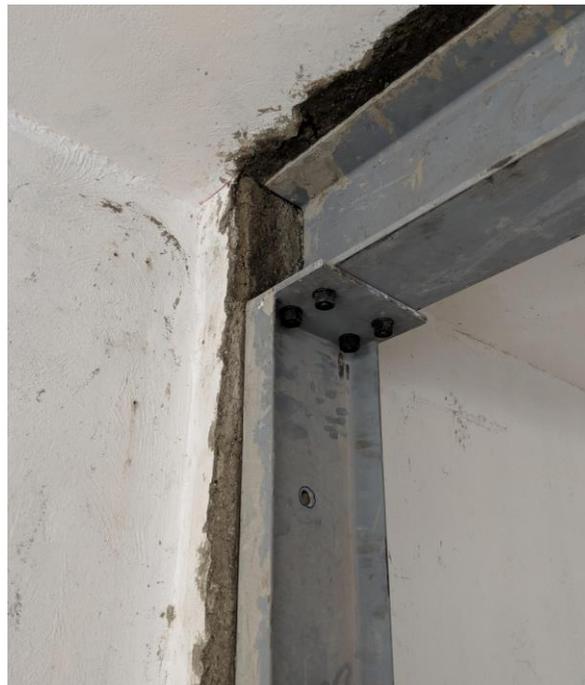
*Image 1 – Structural Steel Reinforcement*

- **Demand over capacity** - The contractor installed a concrete roof but the building was designed to receive a light sheet metal roof. The added demand created by the weight of the roof has led columns to be over capacity, which has resulted in structural failure. The failure of columns has resulted in six beam failures, the structural frame is compromised, and additional seismic activity could cause significant damage.

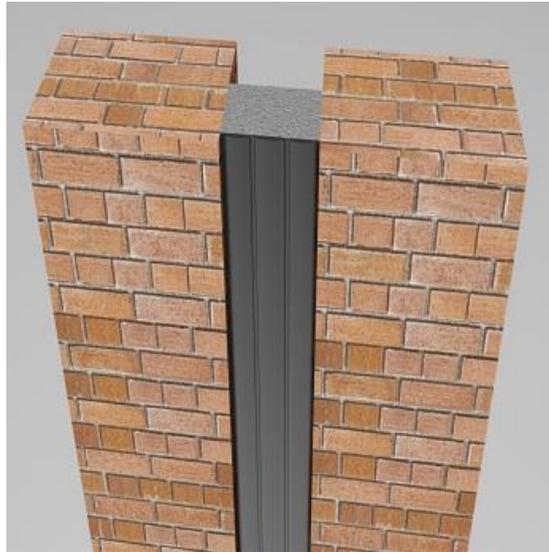
*Image 3 – Expansion joint detail*

- **Lack of expansion joint** - The building was designed as two separate buildings but was built in a single "L" configuration. The buildings were designed to move independently and due to this connection the movement of the structure is strained and causing additional cracking at the intersection. This connection will cause additional issue if there is seismic activity as the increased torsion created by this connection could result in additional damage.

3. **Expansion Joint** - A 2"-4" expansion joint needs to be cut at the intersection of the buildings throughout the entire structure to allow for independent movement (Expansion joint location can be found on diagram 2). This will reduce torsion and help prevent cracking of walls at connections in normal conditions. It will also help prevent extreme failure caused by added torsion in a seismic event (A typical expansion joint detail can be seen in image 2).
